MORTON THIOKOL INC.
Space Operations

**Assembly Test Article (ATA)
Final Test Report**

February 1988

DOC NO. TWR-16829	VOL
SEC	PAGE

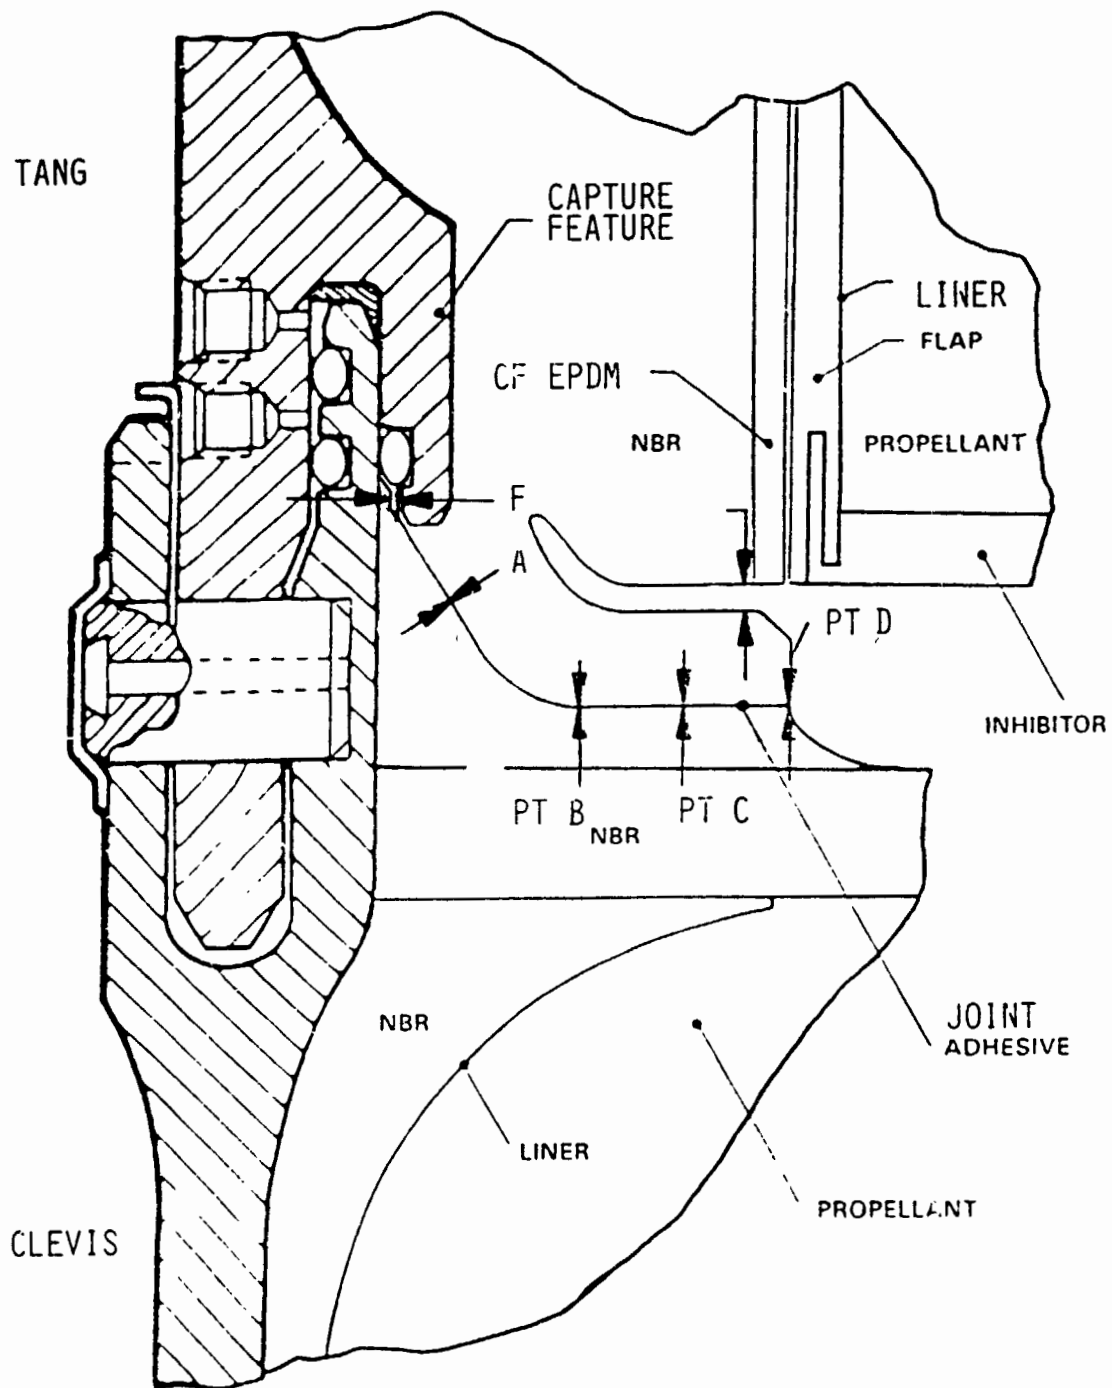
Figure 7-19. Assembled Field Joint Analysis Locations (Cont)

**Dat was requested in the test plan but was not taken for the clevis joint
#Analysis at 75°F, vertical assembly

NOTE: " - " indicates interference

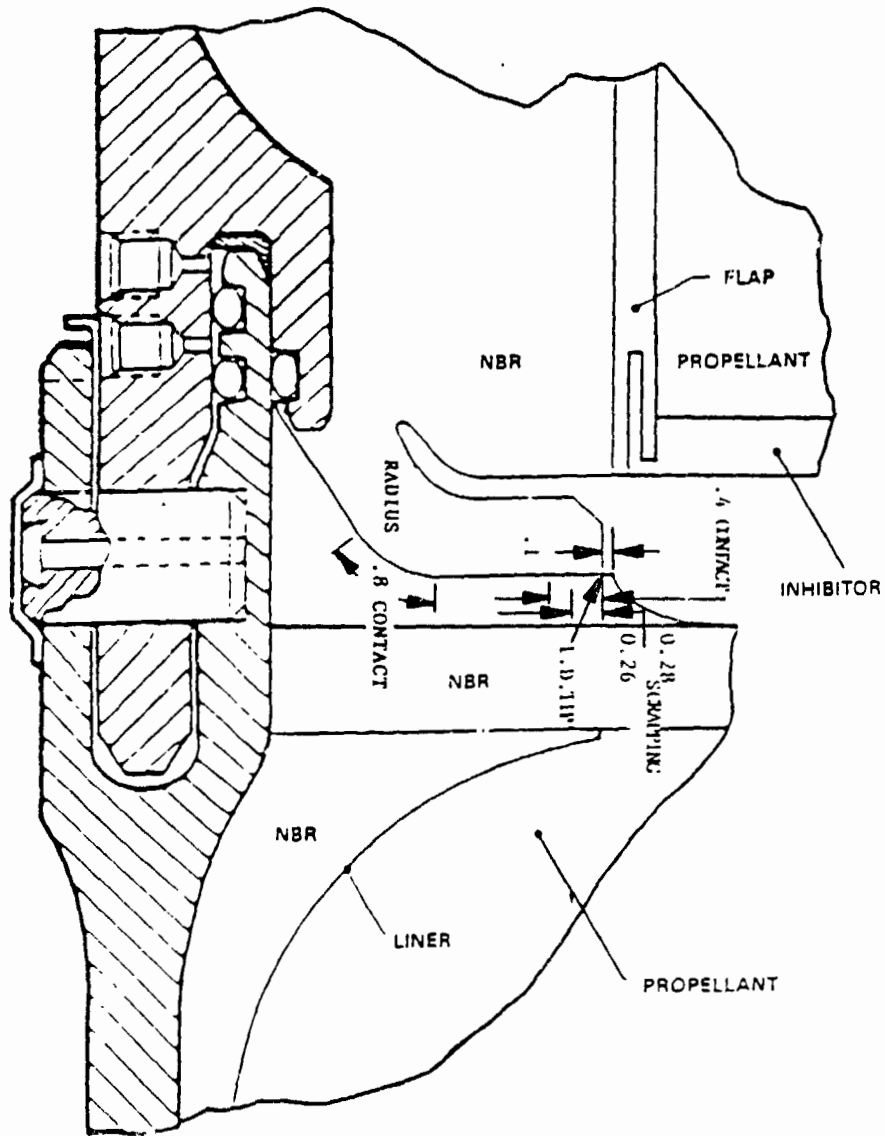
Figure 7-21. Dry Fit Inspection Summary

The dry fit inspection of ATA, using transfer medium, showed contact full circumference at the J-seal ID tip (0.40 to 0.45 in. radial engagement typical) and at the joint radius (0.8 to 0.9 in. surface length around the radius) as shown in Figure 7-21. Radial contact was shown for short arc lengths from 0.35 in. minimum to 0.65 in. maximum. No contact was noted between the engagement at the ID tip and the engagement at the radius or between the engagement at the radius and the NBR/case interface. At assembly, the tang J-seal tip engaged and scraped 0.25 to 0.28 in. of powder off the clevis surface. Engagement stopped with the tang tip 0.08 to 0.09 in. outboard of the clevis seal surface ID. A portion of the engagement face of the tang J-seal was masked out by the powder being scraped off at engagement but did not significantly affect the demate inspection. Joint contact in the radius did not affect contact at the joint ID tip. Engineering design nominal radial contact at the tip is 0.201 in. with the segment vertical and the propellant mean bulk temperature (PMBT) at 75°F. Joint contact at the tip exceeded the design nominal despite the contact in the joint radius. Table 7-11 shows the deg locations and the radial contact distance at the ID tip of the J-joint tang leg as measured with a 6-in. scale.

Definition of joint contact using indications of transfer powder was somewhat subjective. Transfer varies from almost no transfer to heavy transfer and is affected somewhat by the local thickness of application, the J-joint assembled load, possibly by how level the segments are at assembly and disassembly, and possibly by environmental effects on the transfer medium. The degree of transfer noted during the dry fit inspection is summarized in Table 7-12.

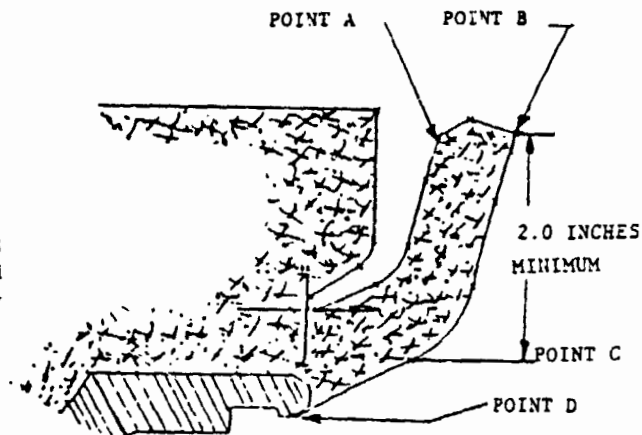
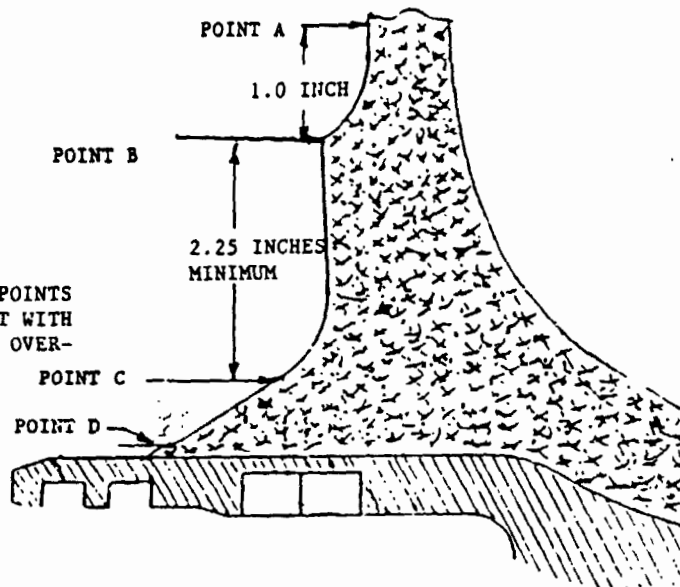
Figure 7-22. J-seal and Insulation Adhesive Surface Preparation

Prior to abrading the joint surfaces, grease had been removed from the joint surfaces. The steel and NBR joint surfaces had been cleaned with trichloroethane. Following the abrasion process, the joint surfaces were again cleaned and the NBR portions of the joint were masked using Velostat® (black anti-static plastic sheeting) and aluminum conductive tape. The joint was masked as described in TWA-1177 and shown in Figure 7-22. TWA-1177 calls out the use of yellow vinyl tape and Kraft paper but the use of both materials was disapproved. Vinyl tape caused too much static charge when being removed from the tape roll and probably would have at removal from the masked surfaces also. The Kraft paper is flammable and was not allowed for use. The actual figures from TWA-1177 were added to the OMI by deviation with the above noted material changes included. It is recommended that TWA-1177 be changed to reflect the use of Velostat® and aluminum tape.

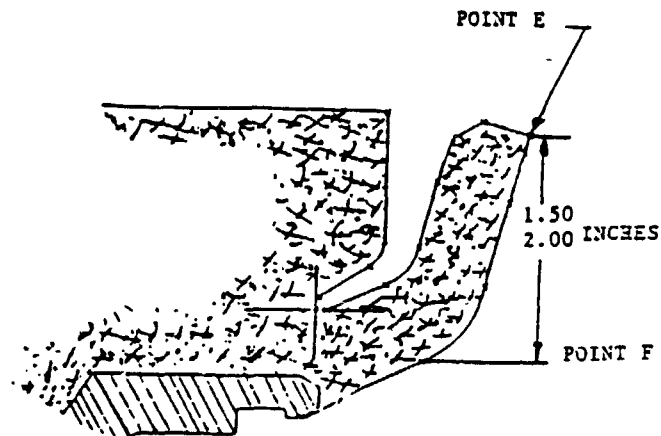
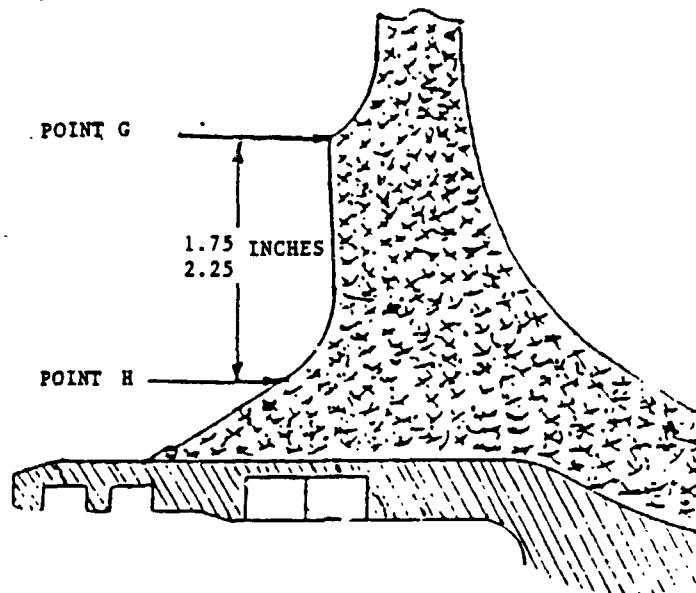
Figure 7-23. J-seal and Insulation Adhesive Application Surfaces

The solvent dispersed joint adhesive (STW5-3479) was applied using 2-in. wide foam brushes as described in TWR-1177 and shown in Figure 7-23. Insulation design engineers began the application to the tang joint surface to show the operators the method of application. The forward end of the aft segment was completely covered by Velostat[®] at this time to prevent adhesive from dropping and contaminating the clevis joint surfaces or the greased clevis surfaces. KSC operators then began the application of the adhesive from the starting point and progressed in both directions around the joint to completion. After removing the Velostat[®] from the aft segment, the clevis joint surfaces were also prepared with joint adhesive by KSC technicians using the same methods. Adhesive was applied to the joint surfaces as shown in Figure 7-23 and typically extended from the joint ID to halfway around the radius. It required less than 20 min and less than 1 qt of adhesive to prepare each joint, however, if a problem were to be encountered, the adhesive would most probably exceed its pot life prior to completing application and an additional kit would be needed. Small discrepancies were noted in the application where the adhesive was applied up into the radius area, out of the tolerance zone. This condition would

not have affected the joint operation but was repaired by removing the excess adhesive with lint free cloths and trichloroethane to comply with application tolerances.
